**Traditional Reserve Study  
For  
VillaSol Community Development District  
Kissimmee, Florida  
February 26, 2024**

**Report Number: 2024.02.26.205**

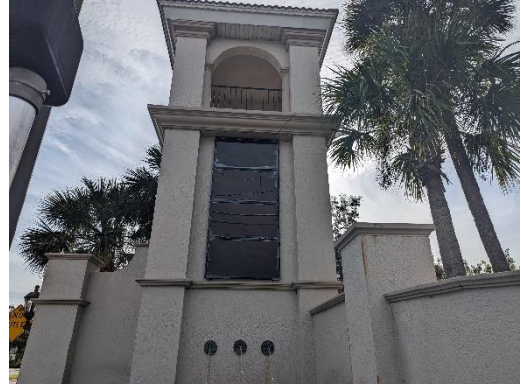
**ID:** 001

- **Entrance Signage. Monuments, Partial** – This provides for the replacement of all entrance signage monuments. The estimated remaining useful life is 65 years and so the total replacement cost is excluded from the study. A periodic failure rate of 5% every 3 years is included in the study as the estimated costs are significant.

**Item Description:**  
Entrance Monument

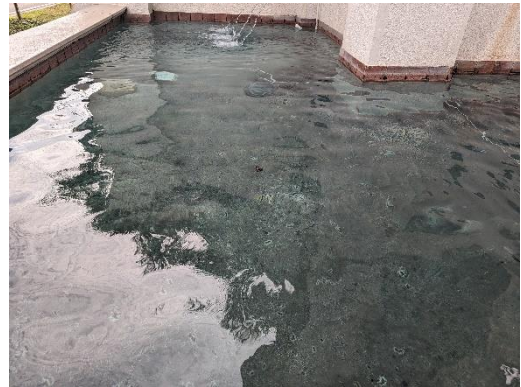
**ID:** 002

- **Entrance Signage, Fountain Resurfacing** – The fountain is approximately 459 square feet. It is in poor condition.
- **Entrance Signage, Paint** – There is approximately 3,764 square feet of paint between the entrance signage and irrigation enclosure. It is running, stained and in poor condition.

**Item Description:**  
Fountain

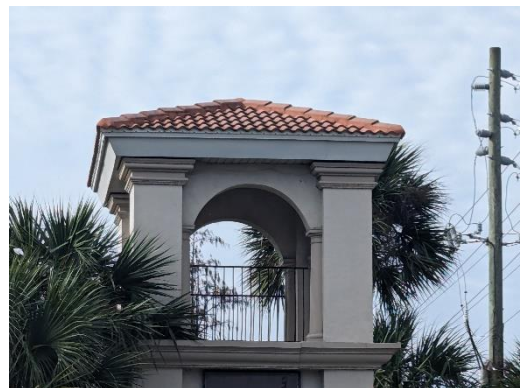
**ID:** 003

- **Entrance Signage, Roof, Terracotta** – There are approximately 2 squares of terracotta roof. Did not have access. No condition assessment is available.

**Item Description:**  
Entrance Signage, Terracotta Roof

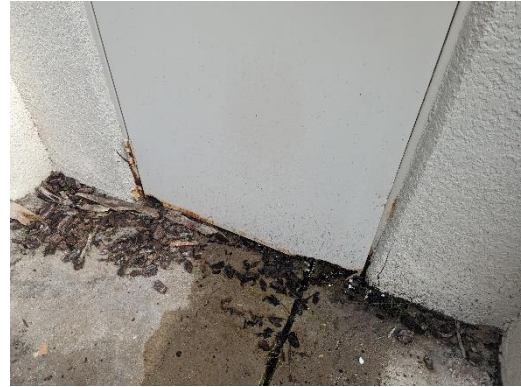
**ID:** 004

**Item Description:**  
Fountain Pump

**Note:**  
Door in poor condition. Considered operational Did not have access.

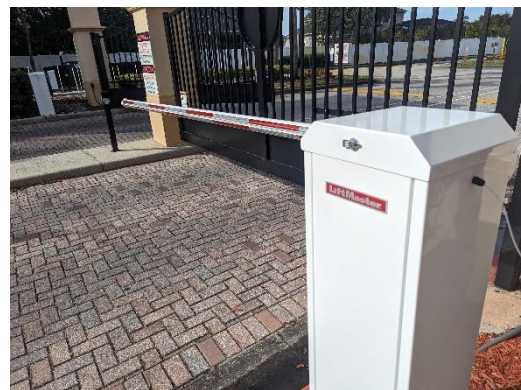
**ID:** 006

- **Entrance Gate Motors** – There are 4 entrance gate motors. They appear to be in very good condition.
- **Entrance Gate Motors with Barrier Arms** – There are 4 entrance gate motors with barrier arms. Two of the arms have been removed and one was laying on the ground during the time of the inspection. Other than the arms, they are in very good condition.

**Item Description:**  
Entrance Gate Motor with Barrier Arm

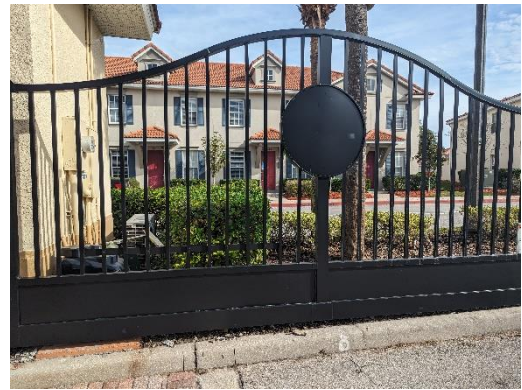
**ID: 008**

- **Entrance Gates** – There are 3 aluminum entrance gates. One is missing. They appear to be in very good condition.
- **Entrance Signage, Fountain Pump** – Did not have access to the pump room. No condition assessment is available.

**Item Description:**  
Entrance Gate

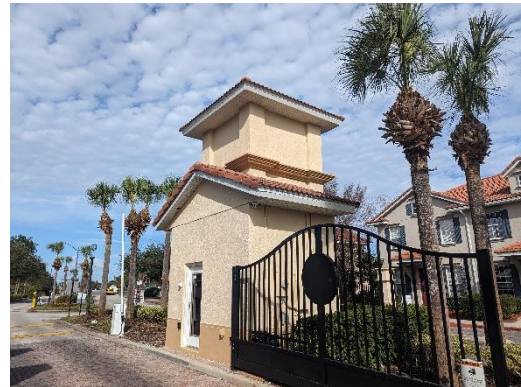
**ID: 010**

- **Exterior Paint and Waterproofing** – There is approximately 1,100 square feet of exterior painting and waterproofing on the guardhouse. It is in fair condition.
- **Roof, Terracotta** – There are approximately 5 squares of terracotta roof. It appears to be in good condition.

**Item Description:**  
Guardhouse Exterior Paint

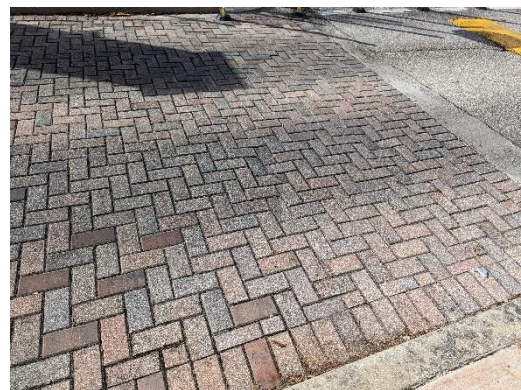
**ID: 012**

- **Road Pavers** – There are approximately 1,904 brick pavers by the security building. There are uneven pavers by the inside entrance area, however, the rest appear to be in good condition.

**Item Description:**  
Road Pavers

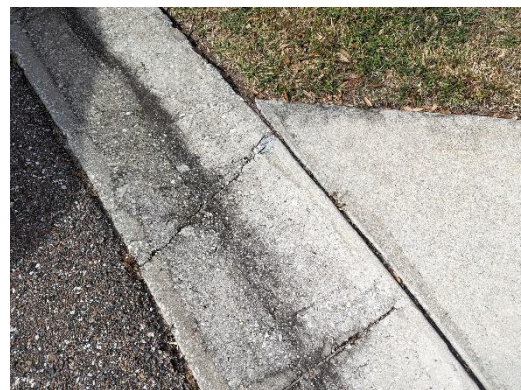
ID: 015

- **Curbs and Road Gutters** – There are approximately 27,200 linear feet of curbs and road gutters. There are damaged areas throughout the property, but overall, it is in good condition.

**Item Description:**  
Curbs and Road Gutters

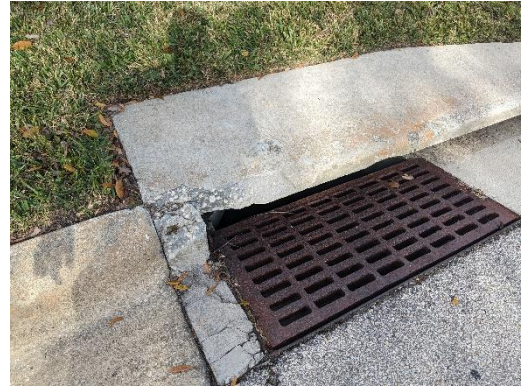
**ID:** 022

**Item Description:**  
Stormwater System

**Note:** Damaged catch basins.

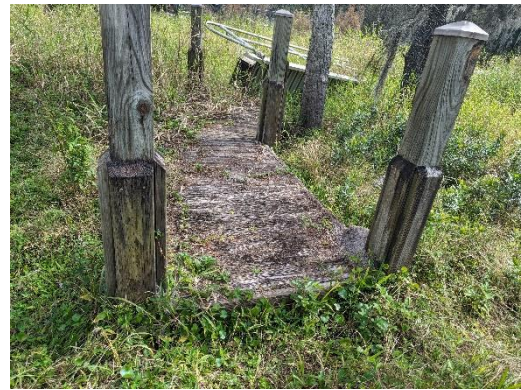
**ID:** 023

- **Dock** – Dock has been damaged by hurricane. Unable to determine length. Due to the condition, we recommend getting a quote from a third-party vendor.

**Item Description:**  
Dock/Boat Area

**Note:**  
Unable to measure.

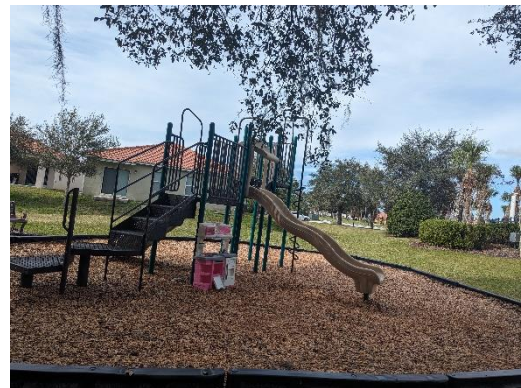
**ID:** 024

- **Playground** – There is one playground. It is considered to be in poor condition based on its age.
- **Small Basketball Court, rebuild** – The small tennis court is approximately 1,600 square feet. It is showing cracking throughout. It is in fair condition.

**Item Description:**  
Playground

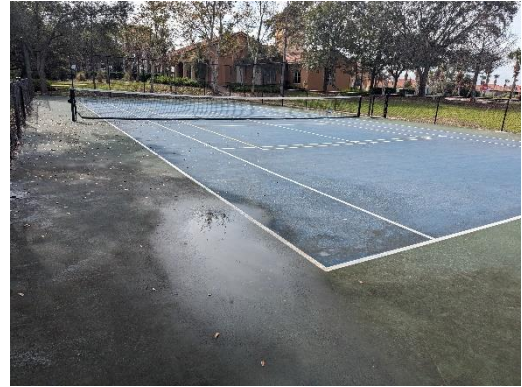
**ID:** 025

- **Tennis Court, rebuild** – The tennis court is showing signs of cracking throughout. These cracks do not appear to be surface only. Overall, it is in good condition.

- **Tennis Court, Resurfacing** – The basketball court is showing signs of cracking throughout. Overall, it is in poor condition.

**Item Description:**  
Tennis Court

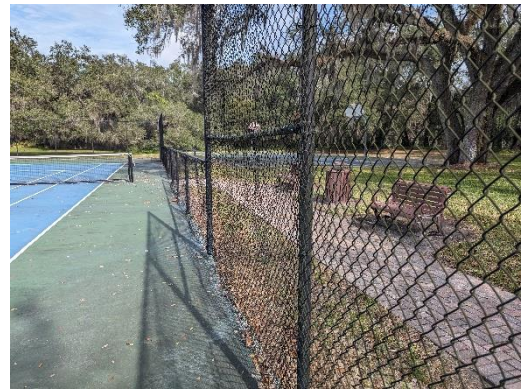
**ID:** 026

- **Tennis Court, Fencing, Chain Link** – The tennis court fencing is approximately 340 linear feet. The chain link is bent from wear. Overall, it is in fair condition. It is typically replaced at the time of rebuilding the court.

**Item Description:**  
Tennis Court Fencing

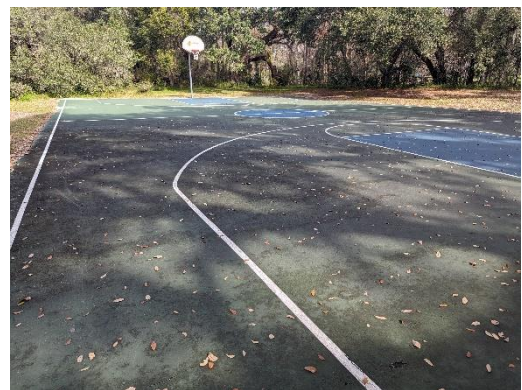
**ID:** 027

- **Basketball Court, rebuild** – The basketball court is showing signs of cracking and has water damage in several areas. These cracks do not appear to be surface only. Overall, it is in good condition.

- **Basketball Court, Resurfacing** – The basketball court is showing signs of cracking and has water damage in several areas. Overall, it is in poor condition.

**Item Description:**  
Basketball Court

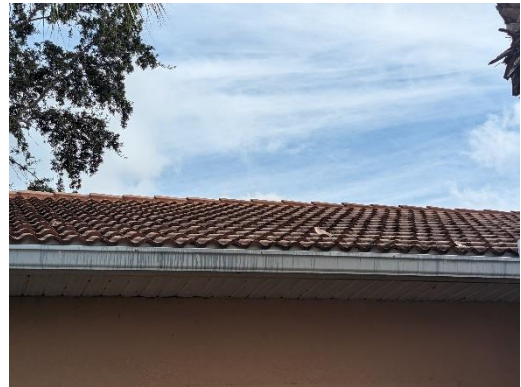
ID: 029

- **Roof, Terracotta** – There are approximately 72 squares of terracotta roof on the clubhouse. It is damaged from the hurricane and is leaking. It is in poor condition.

**Item Description:**  
Clubhouse Roof

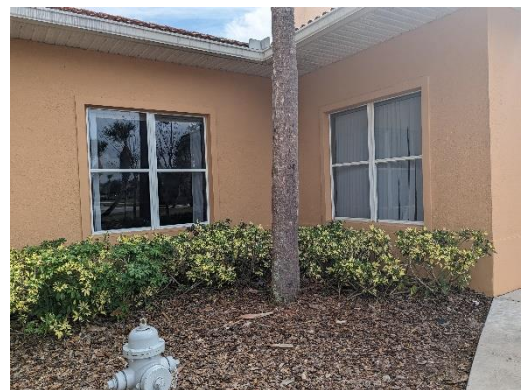
ID: 030

- **Exterior Bathrooms** – There are two exterior bathrooms. They appear to be in good condition.
- **Exterior Paint and Waterproofing** – There is approximately 3,590 square feet of exterior painting on the clubhouse. It appears to be in fair condition.

**Item Description:**  
Clubhouse Exterior Paint

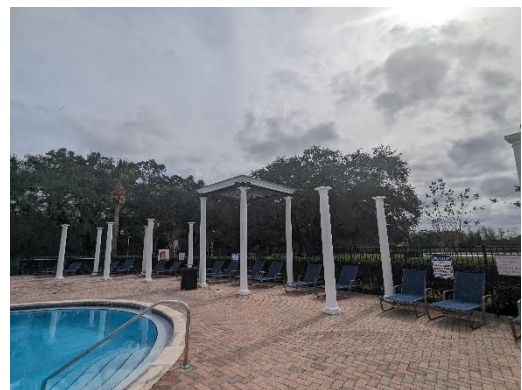
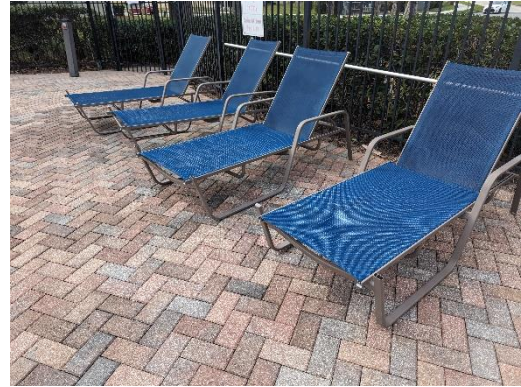
- **Trellis, Wood, Allowance** – Wood trellises are either missing or in poor condition. This allowance is provided for the removal, disposal, and installation of a new trellis. We recommend getting a third-party quote for this because the association may have different plans than what was originally constructed.

**Item Description:**  
Trellis

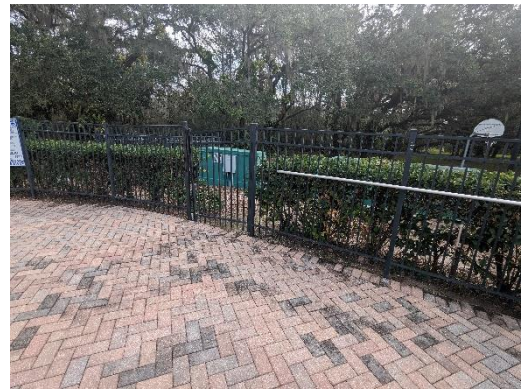
**ID: 047**

- **Equipment Enclosures, Allowance** – There are 4 fiberglass pump enclosures. They are in poor condition.
- **Fencing, Aluminum** – There are approximately 324 linear feet of aluminum fencing. There are some bent and damaged areas, including the gates. Overall, it is in fair condition.

**Item Description:**  
Aluminum Fencing

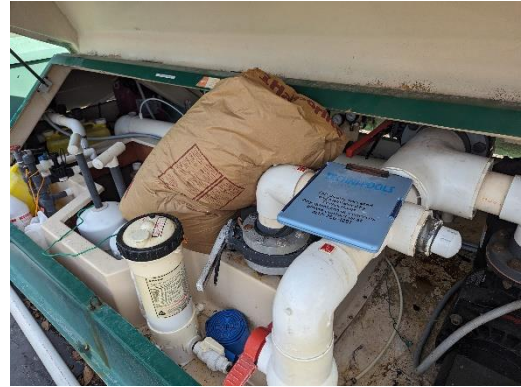
**ID:** 049

- **Pool Deck, Brick Pavers** – There are approximately 6,500 square feet of brick pavers. They appear to be in good condition.
- **Pool Equipment** – This provides for the replacement of pool pumps, motors, separation tanks and other related items. The 1.65 hp motor does not appear to be working at the time of the visit. Overall, it is in poor condition.

**Item Description:**  
Pool Equipment

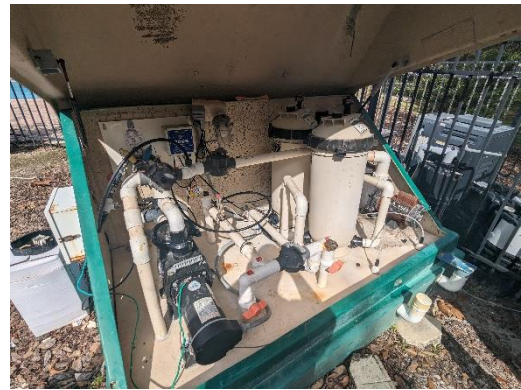
**ID:** 050

- **Pool, Remarcite** – The pool surface area is approximately 3,325 square feet. It appears to be in good condition.
- **Spa Equipment** – This provides for the replacement of the spa pumps, motors, filters, chemical controller, and other related components. They are in poor condition.

**Item Description:**  
Spa Equipment
