VillaSol
Community Development District

**Traditional Reserve Study
For
VillaSol Community Development District
Kissimmee, Florida
January 31, 2024**

Report Number: 2024.01.31.205

Field Management Report

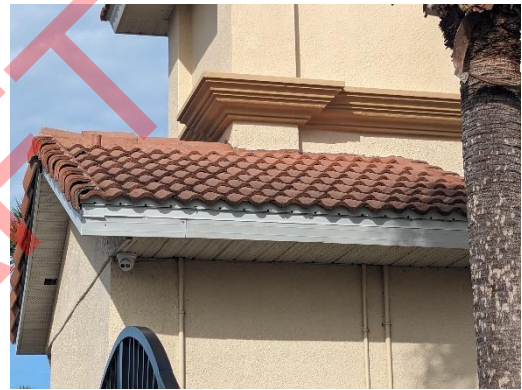
Item Description:
Guardhouse Terracotta Roof

- **Exterior Paint and Waterproofing** – There is approximately 1,100 square feet of exterior painting and waterproofing on the guardhouse. It is in fair condition.
- **Roof, Terracotta** – There are approximately 5 squares of terracotta roof. It appears to be in good condition.

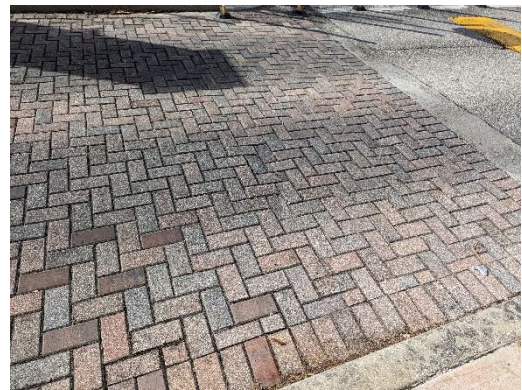
Item Description:
Road Pavers

- **Road Pavers** – There are approximately 1,904 brick pavers by the security building. There are uneven pavers by the inside entrance area, however, the rest appear to be in good condition.

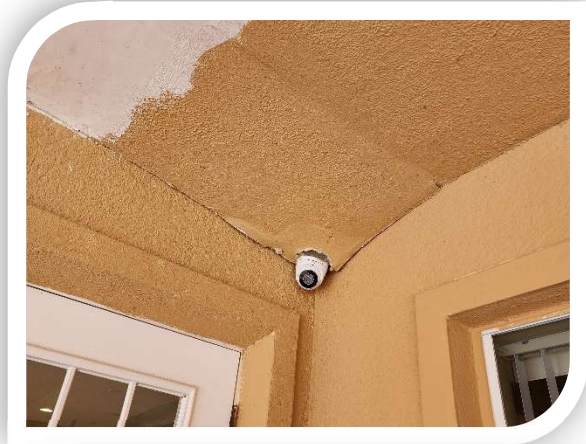
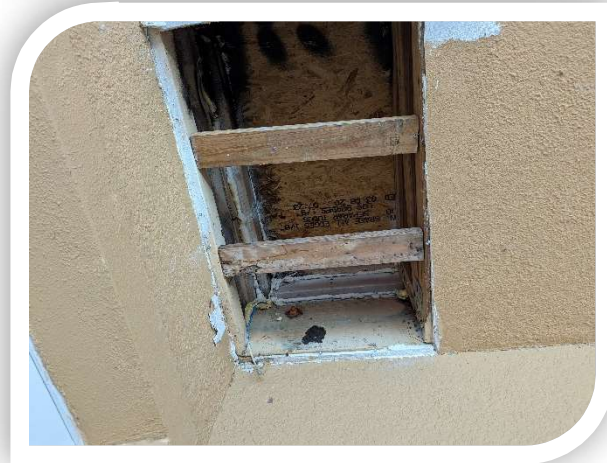
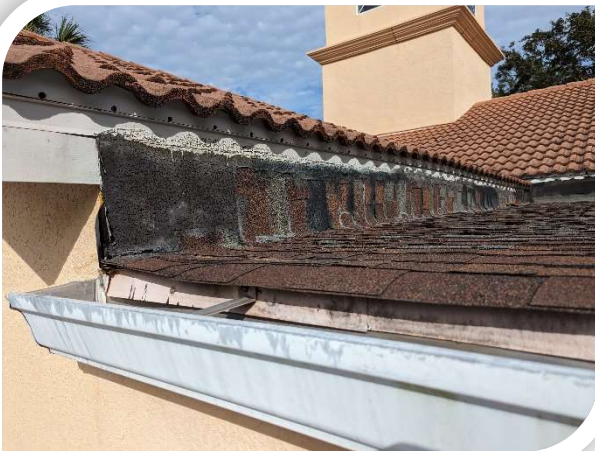
Clubhouse Maintenance

- ✚ GMS Staff repaired the pool deck ceiling that was falling. This is only a temporary fix as the roof above is leaking and the plywood is rotting. Recommend replacing the flat roof section as soon as possible, and we have begun gathering proposals.
- ✚ No Trespassing signs provided by the sheriff's office were installed.

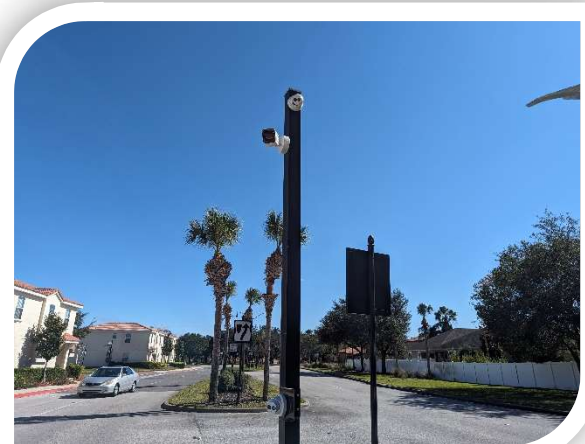
Guardhouse Cameras

- + All cameras at the guardhouse have been installed.
- + There is a License Plate Reader camera at both the entrance and exit lanes. These cameras take pictures of each plate and have live video making it easier to identify vehicles.

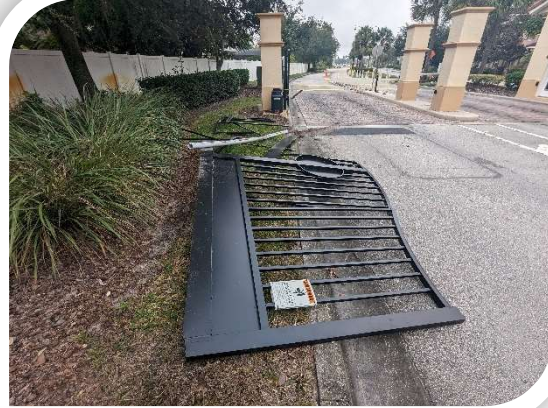
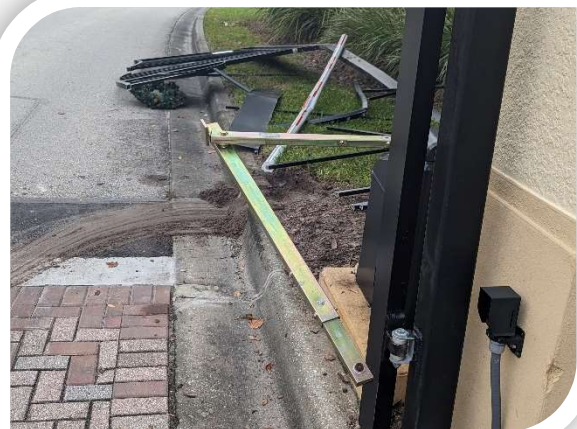
Gate Update

- ✚ The gate repair is in progress and currently being powder coated.
- ✚ Expected installation is 2/16/2024 as long as powder coating is completed.
- ✚ New LED gate arms were delivered for the exit lanes and will be installed by GMS staff.
