VillaSol Community Development District

Agenda

March 19, 2024

Traditional Reserve Study For VillaSol Community Development District Kissimmee, Florida February 26, 2024

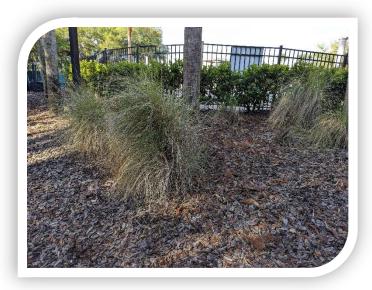
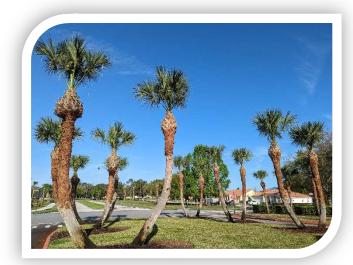
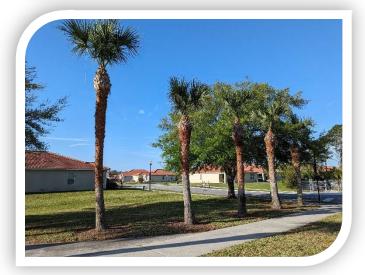
- Palm boot pruning of CDD property has been completed.
- Ornamental grasses will be reset to promote healthy growth and aesthetic.

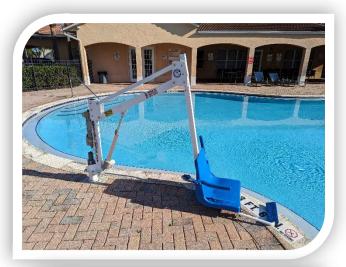
- New filter grids and ADA chair lift battery and controller were installed.
- Received proposal to replace pool spa heater with gas powered option.
- Gas lines in the facility were inspected and appear to be in working order. Propane tanks will need to be refilled.
- The ADA chair lift motors are broken and need to be replaced, along with the chair cover.
- Vendor provided cost for 2 X weekly servicing for the fountain. This was left off the original contract by mistake.
